**REPORT NUMBER: WI/SPR-02-02**

# **STONE MATRIX ASPHALT THE WISCONSIN EXPERIENCE**

**FINAL REPORT**

FINAL REPORT WI/SPR-02-02  
WisDOT Highway Research Study # 91-07  
SPR # 0092-45-87

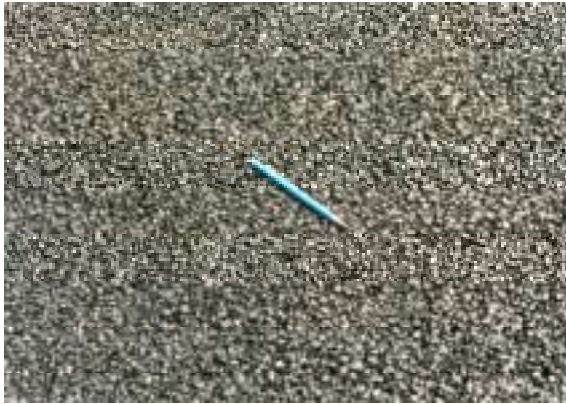
**Photograph 1: SMA Surface**

The design of the SMA mixes differ from the standard mix in several ways. Primarily, the SMA mixes use a gap-graded aggregate, while the standard mixes use an aggregate gradation that is more evenly spread across the gradation band thus producing a more dense mix. The gap-grading of the aggregate in the SMA results in a more open texture, creating stone-on-stone contact with a higher amount of voids in mineral aggregate (VMA) in the mix (See Photos 1-4). The standard AC mix in Wisconsin for these projects averaged 15% VMA, while the SMA mixes had around 17% VMA. Also, the standard AC mix had around 5.3 to 5.6% asphalt binder, while the typical SMA mix had between 6 to 6.7%. The greater amount of asphalt binder in the SMA mixes required that a combination of fines (mineral filler) and a stabilizing agent, usually either a fiber or a polymer, be added to the SMA to keep the asphalt binder from draining from the mixture during the construction process, especially during hauling.

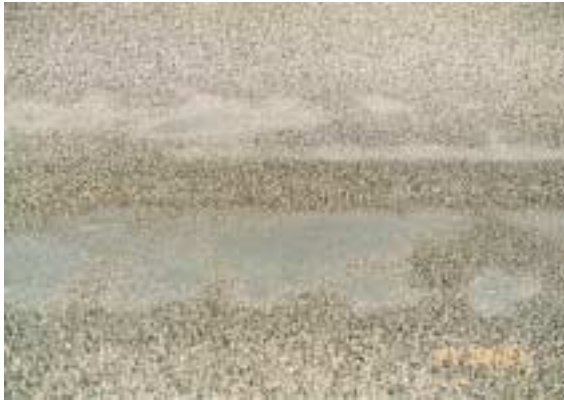
**Photograph 5: Bleeding of SMA Pavement**

Some of the problems experienced during placement have been previously mentioned and will not be reiterated here. Other problems encountered relate to mixture temperature and the sensitivity of SMA's to low ambient temperatures during placement. Proper temperatures were especially critical for the polymer stabilized SMA mixtures. At lay down temperatures much above 305° F (152° C) these mixes tended to bleed, with the polymer pooling and solidifying at the pavement surface (See Photos 5 & 6). On the other hand, at temperatures below 290° F (143° C) the mix would tend to stick in the truck boxes. The elastomeric and thermoplastic stabilized SMA's tended to be much more sensitive than the fiber stabilized mixes regarding these characteristics.
